TEST REPORT

IMR Report Number 201000531

Description
LintAlert System

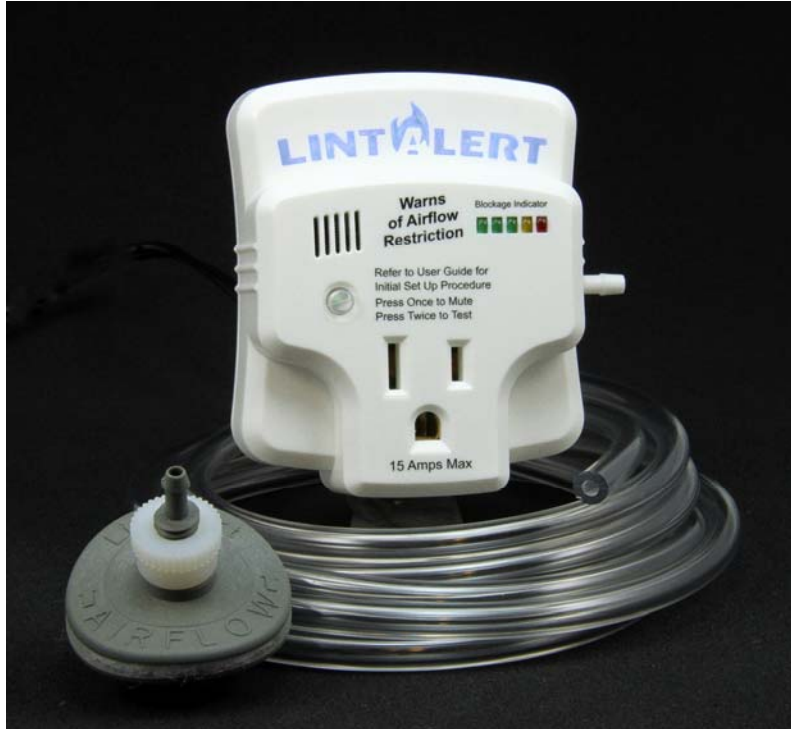
Figure 1: Sample as received – typical.

Three LintAlert Systems (Figure 1) were received to validate the customer stated claims for its use and function. The units were received in two batches, Unit 1 by itself and Units 2A and 2B at a later date after a modification by the client to the firmware regarding the respective upper level set points.

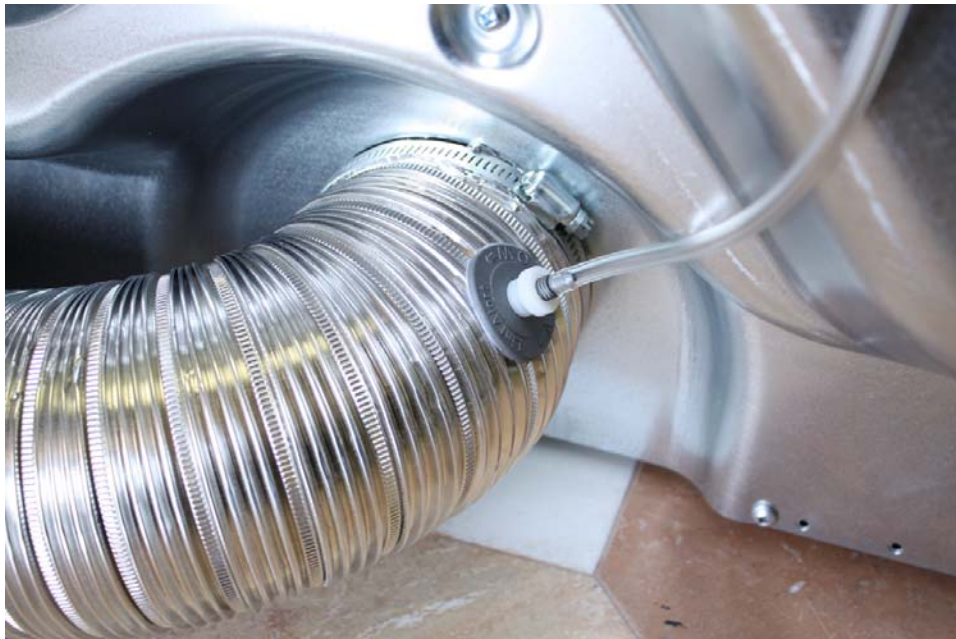
Figure 2: Test setup – installed pressure top.

The systems were installed on a standard clothes dryer in accordance with the supplied instructions (see Appendix) with the following modifications. First, we tee'd off the 1/8" ID tubing to display the analog pressure levels with an industry standard Inclinator that quickly indicates low air pressures up to 2.2 inches of water column (and less precise up to 22 inches of total water column) (see Figures 2 and 3). We also took standard metal flexible dryer venting hose and placed a restricting valve in line to simulate lint buildup (see Figure 4).

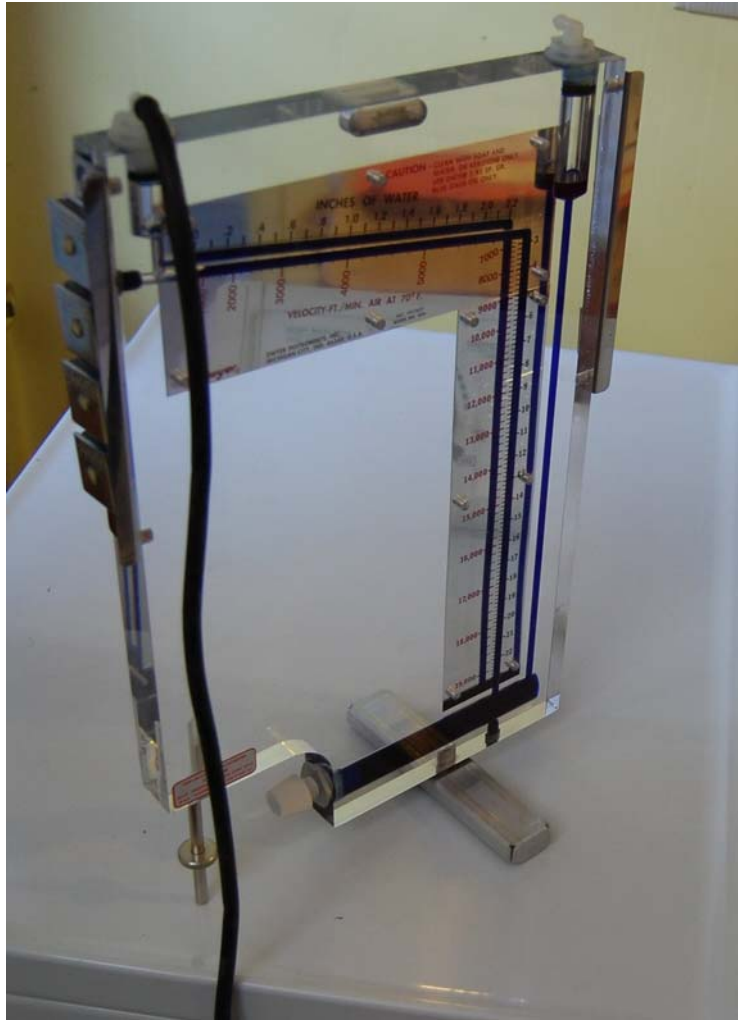
Figure 3: Test setup - Inclinometer

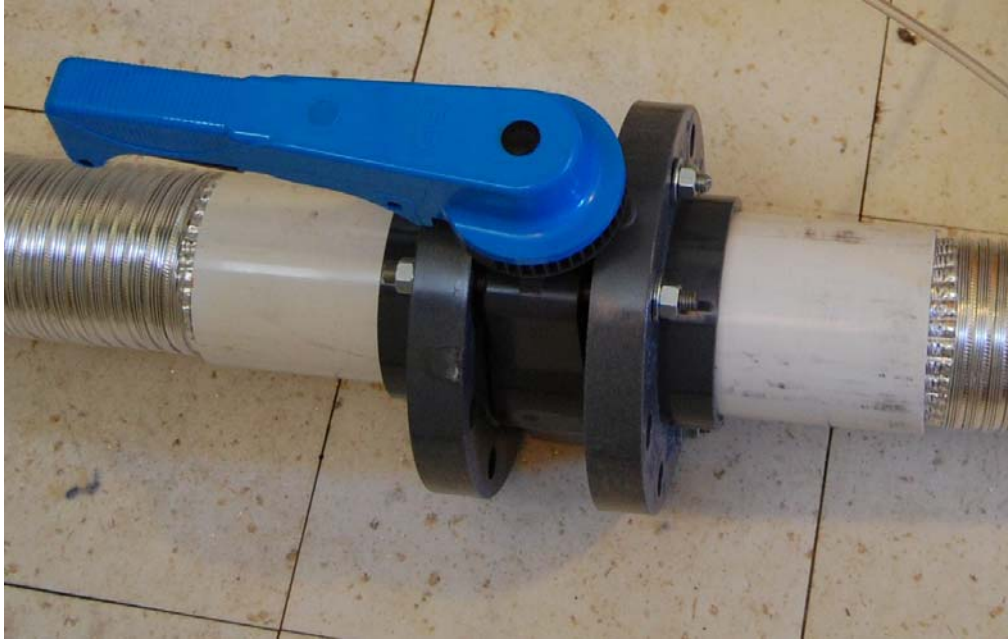
Figure 4: Photo showing standard metal flexible dryer venting hose and restricting valve in line to simulate lint buildup.

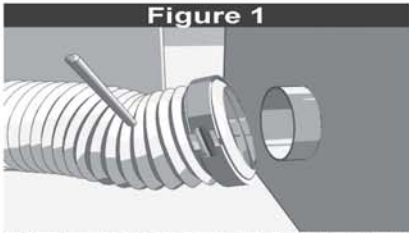
Figure 1
 Poke hole in flex near dryer connection.

2 Step Two
 Disconnect the new or existing exhaust hose from where it connects to the exhaust port on the back of the dryer. Favoring the middle to outside radius of the first bend, **carefully poke a ¼" hole in the hose, close to where the exhaust port connects.** (Figure 1). Be sure to leave room for the flex hose to re-secure to the dryers' exhaust terminal.
